Contractor:  
Varian Associates  
611 Hansen Way  
Palo Alto, Ca. 94303

QUARTERLY TECHNICAL REPORT NO. 3

1.06-Micron Image Intensifier Tube Development

(October-December 1972)

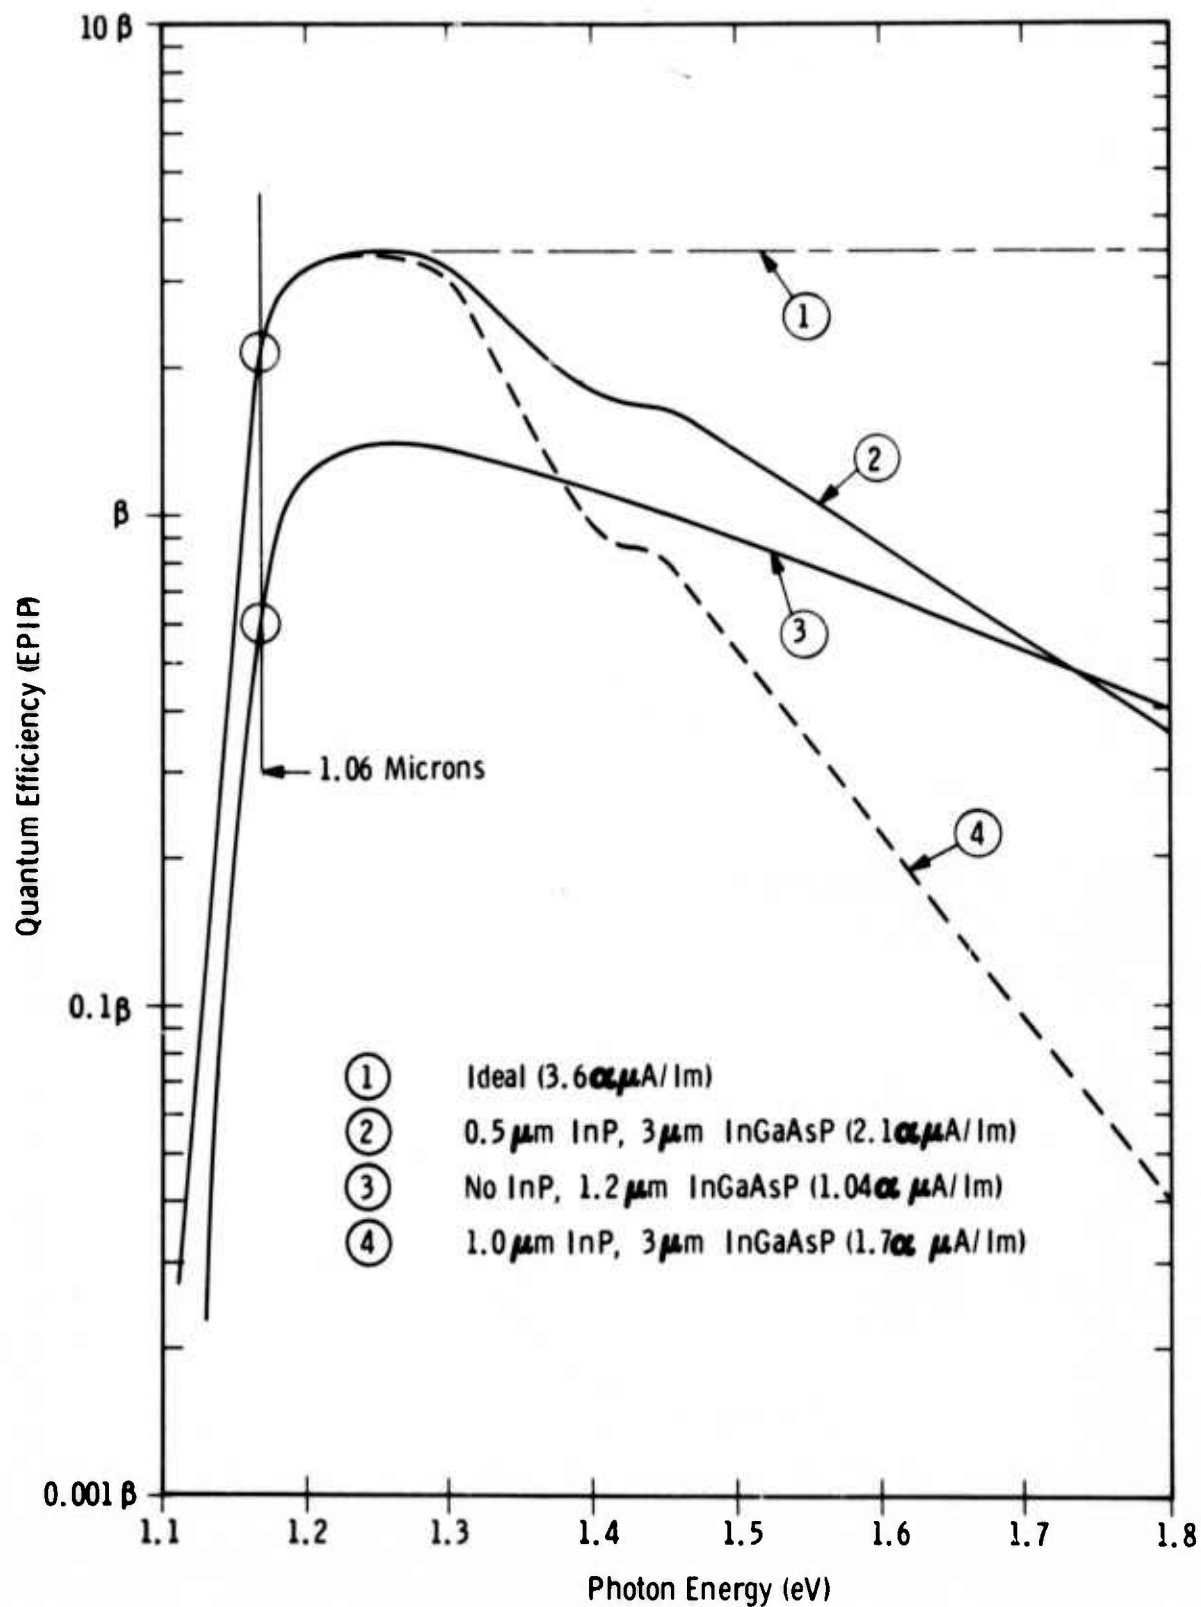
Figure 15. Calculated broadband performance of InGaAsP sealed to glass assuming zero optical reflection, a 1.19 eV bandgap, and a 4-micron diffusion length.

The performance of InGaAsP sealed to glass as a broadband semitransparent photocathode has been calculated and the results are presented in Fig. 15. The assumptions used in the calculations are zero optical reflection, a bandgap of 1.19 eV, a diffusion length of 4 microns, and an escape probability about 15% less than the best accomplished to date. The beneficial effects of a thin layer of InP is apparent, and excellent passive and 1.06-micron performance is indicated. In the coming quarter, cathodes will be fabricated to experimentally verify these calculations.
